TICKHILL BUTTER CROSS

GRADE II LISTED

CONDITION INSPECTION REPORT

For the Tickhill Town Council
Doncaster MBC, Listed Building Legacy ID: 334354 NGR: SK 59278 93281
Date of primary Inspection 6th June 2025
Weather: Dry and hot for some time
Inspection status: First by this Architect

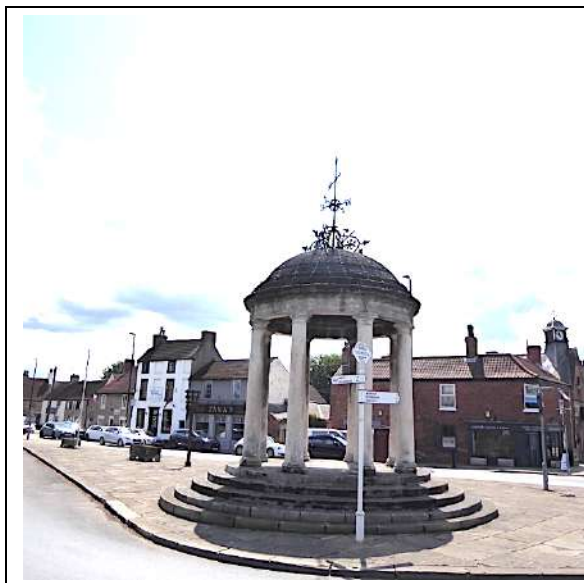
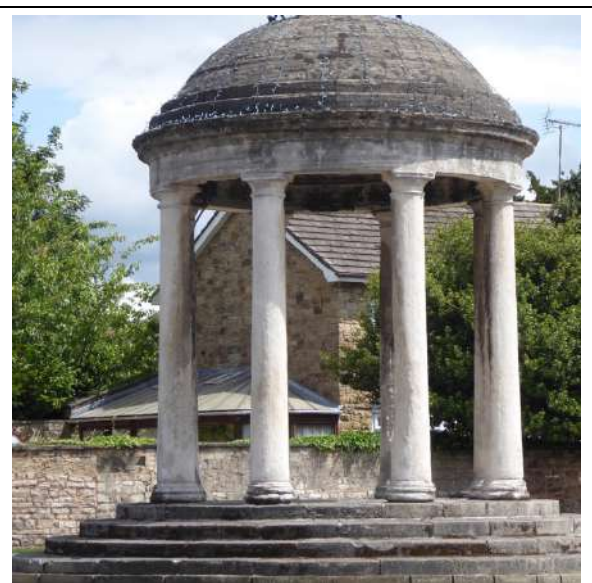
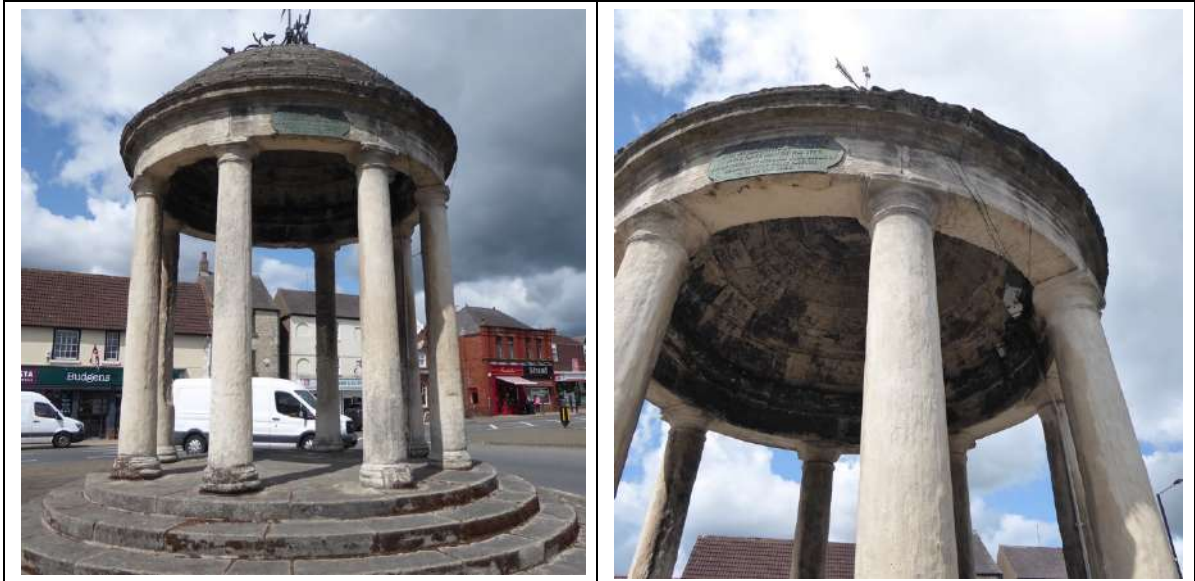
General views of the monument. Column 1 is to the right of the bronze plaque and the numbering runs anti clockwise.

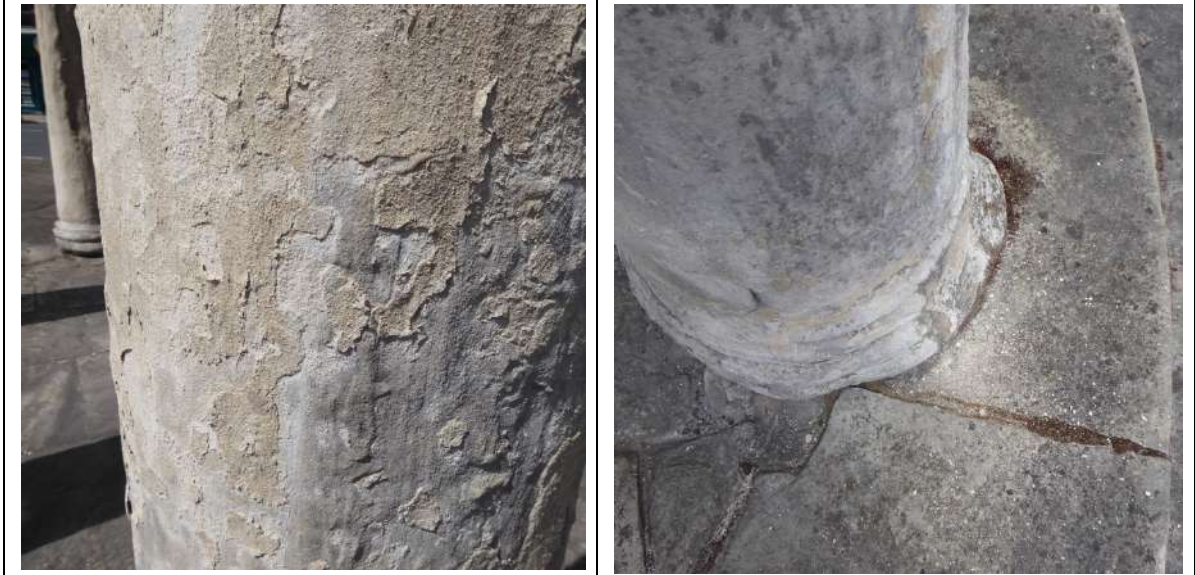
Column 1 (East): Past overcoating of a soft paint can be rubbed away. This may be a soft lime shelter coat which is a good product and should be repeated. If past specifications can not be found to confirm on the material used it may need to be teseted in a lab.

Column 1: Detail of column base. This level of erosion is typical for all.

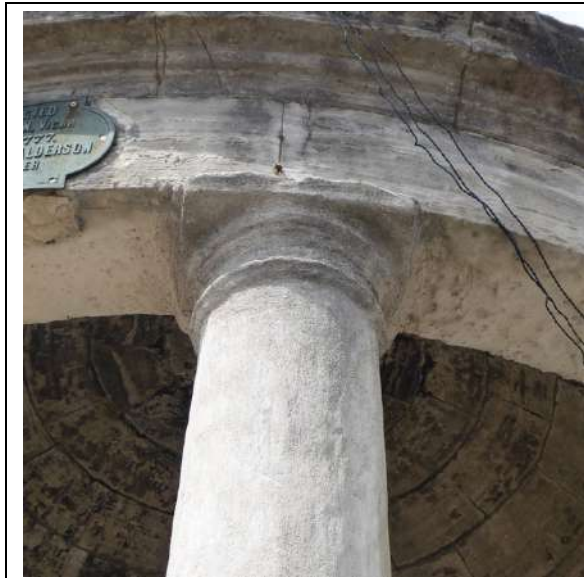
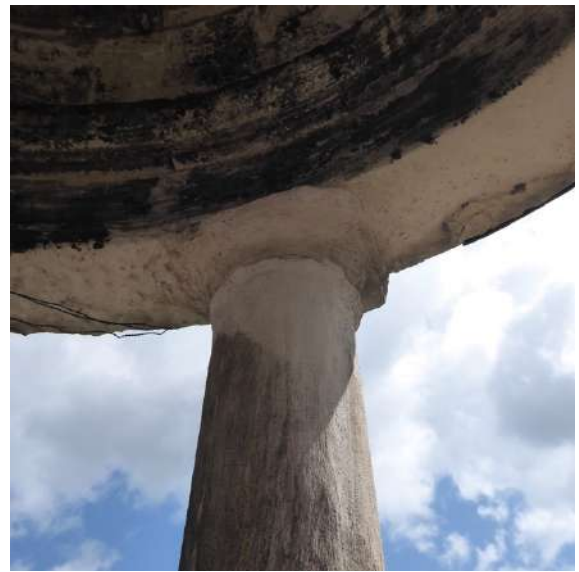
Column 1: Detail of column head. Iron pins in the tintol joint discussed later

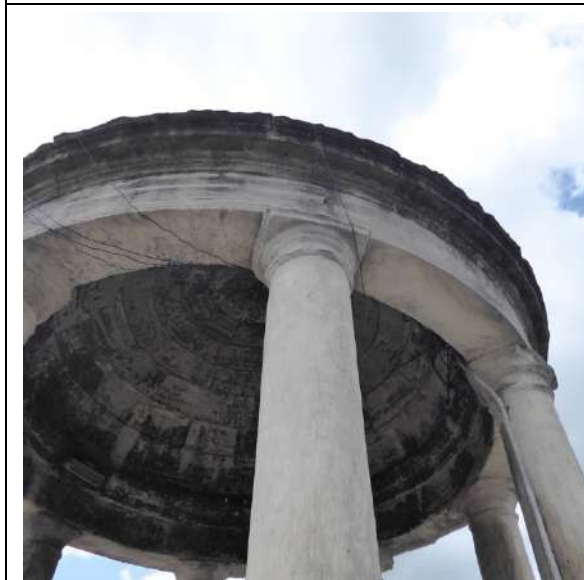
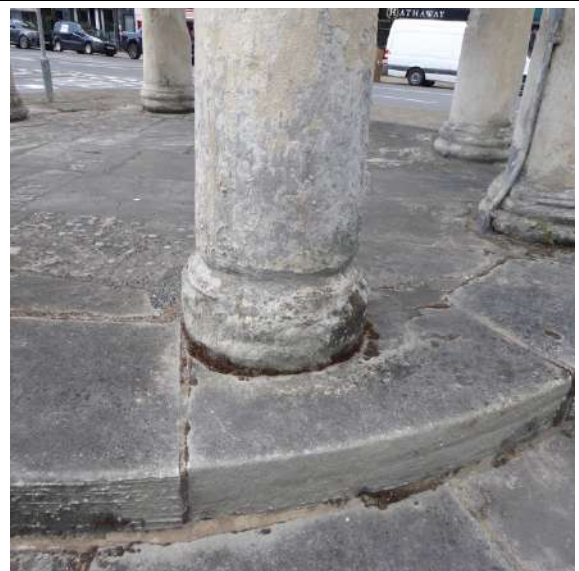
Column 2: general condition

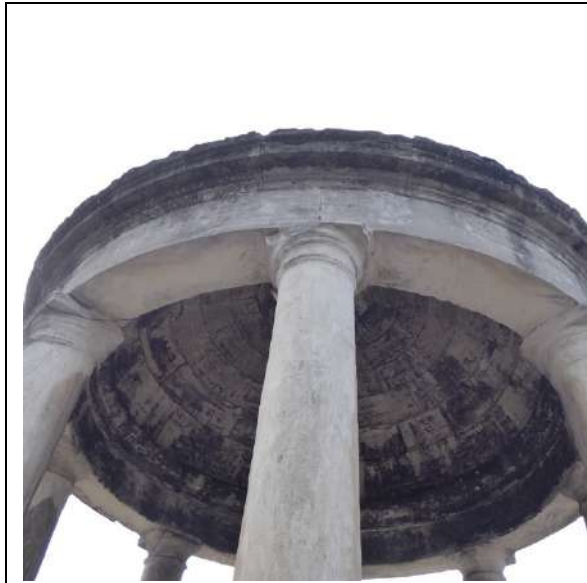
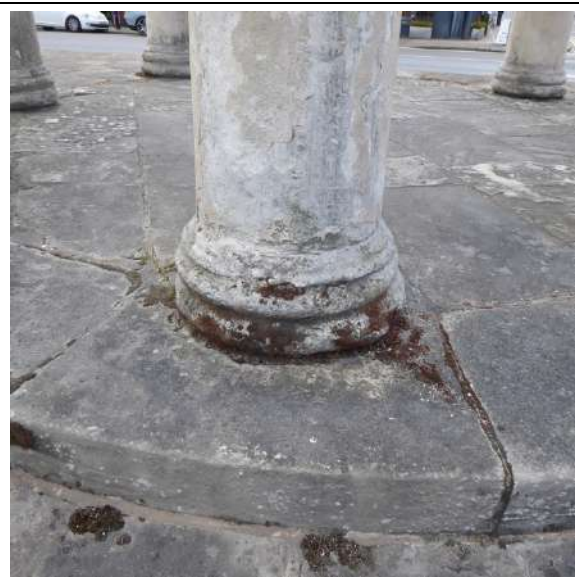
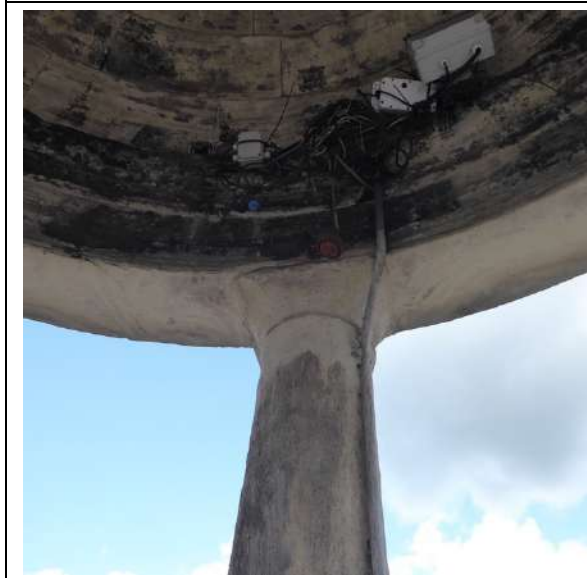
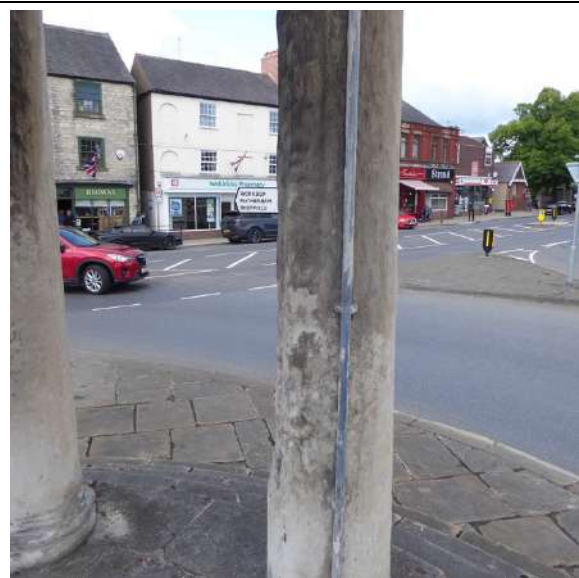
Column 3 (North): General views. This column has the conduit for the electrical feed.

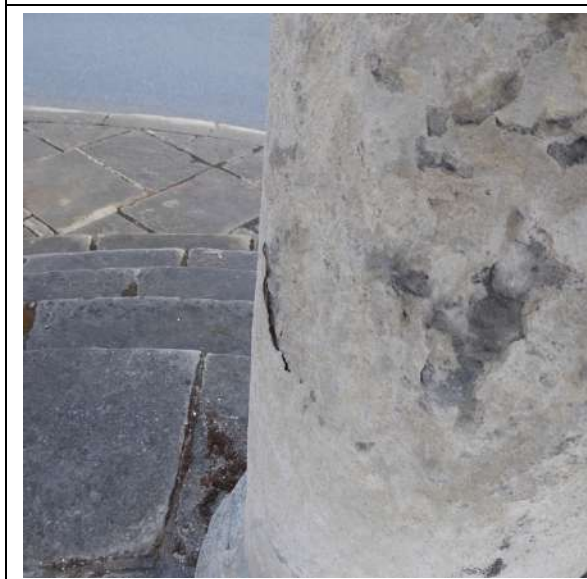
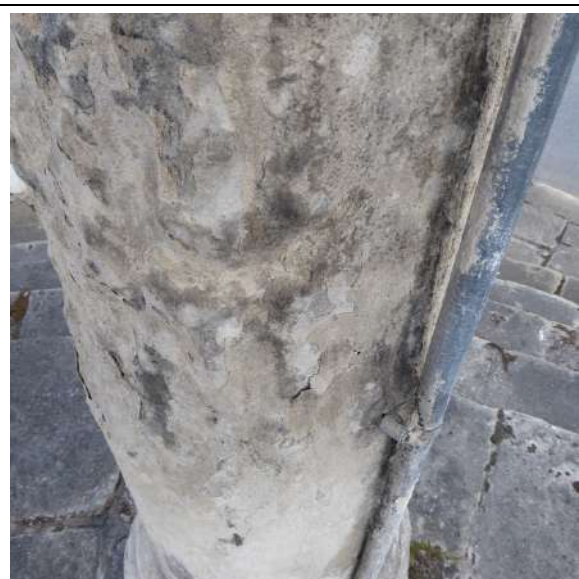
Column 3: The modern surface coating/repair layer is starting to come away on the inside. This needs to be lightly scaled

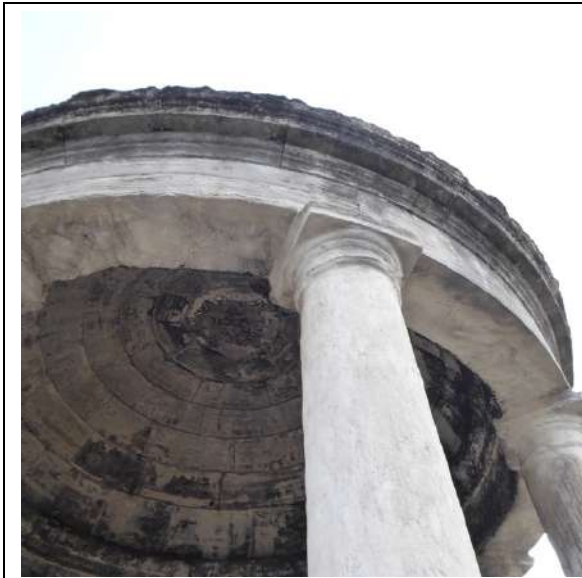
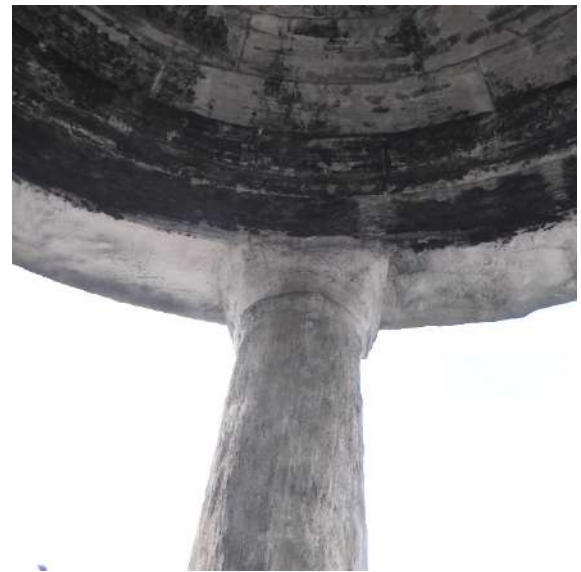
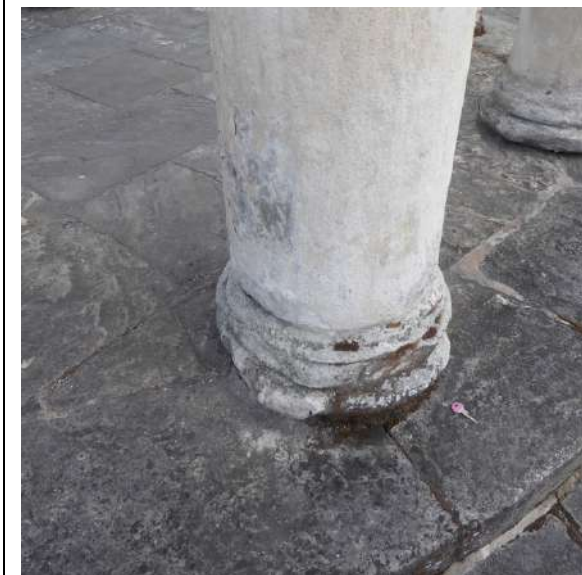
Column 5 (West): This seems in better order than those adjacent but it may be that the paint coating is covering a lot of past surface repair like column 4.

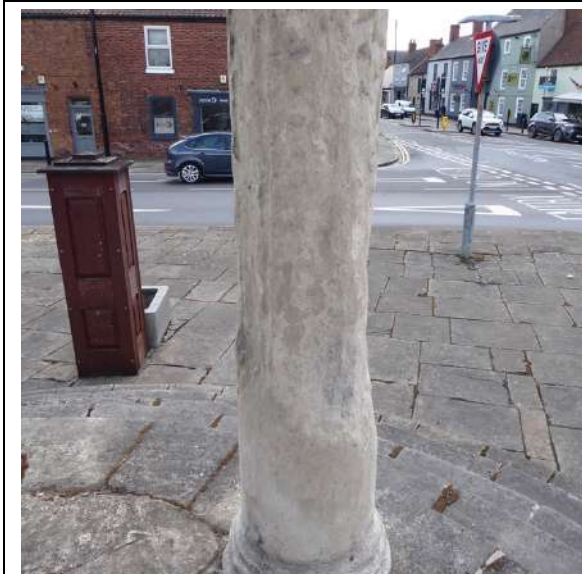
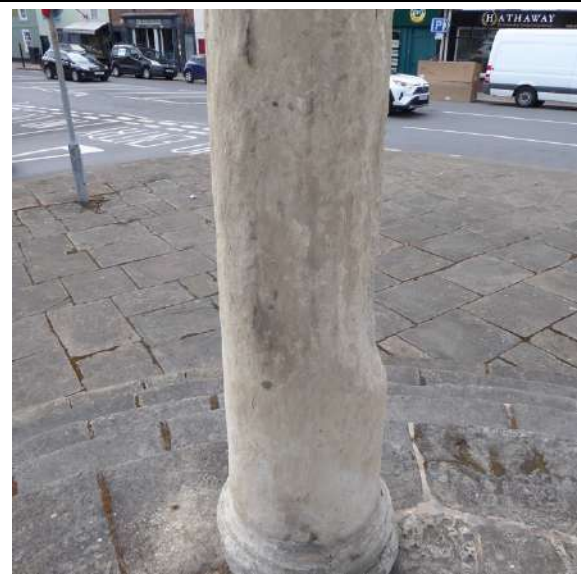
Column 6: This column has the most loss of volume to the shaft due to being the most exposed to wind blowing down the street. The volume loss seems to be more historic and seems to be arrested by the coatings applied in the past.

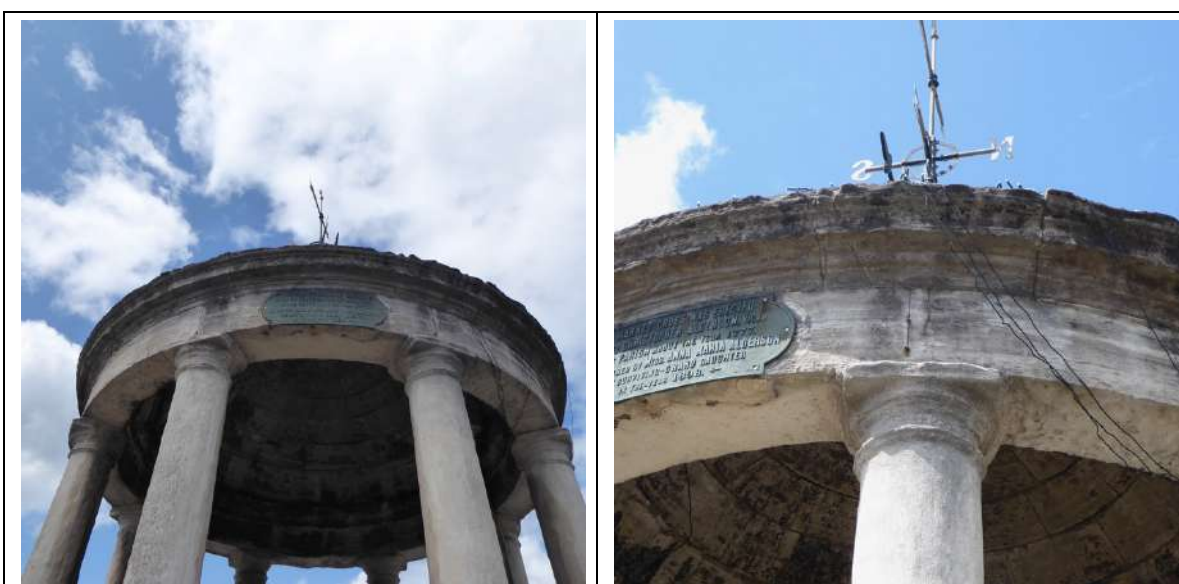
Lintel 1 (East). Showing the general arrangement. Photo also shows the 'nibbled edge' of the encircling cornice. This could be re-defined as a circle by adding a blade of lead into the joint above. It would also help the water drip clear of the

column tops below.

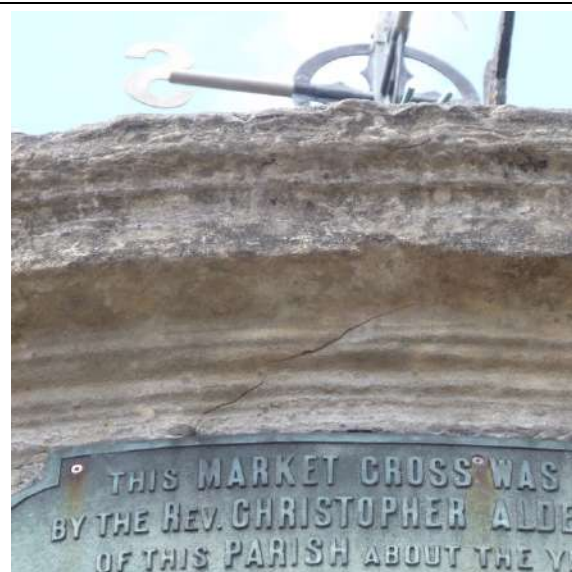
Lintel 1. Crack in the cornice above the plaque. The edges of this are weathered suggesting it is an old fissure. The cornice and the lintel are two different blocks of stone.

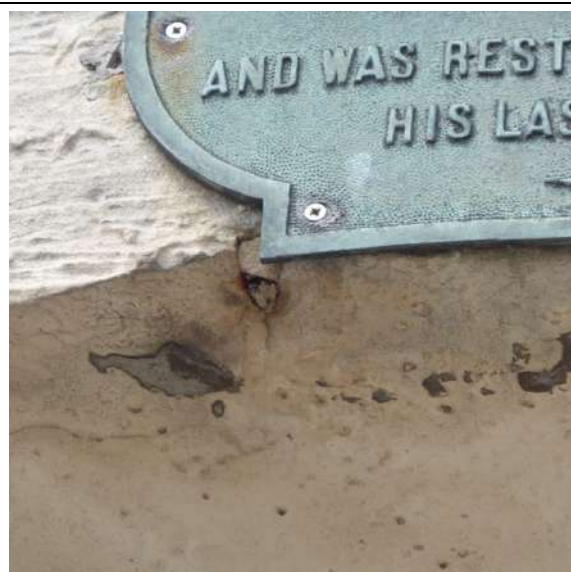
Lintel 1. Edge damage cause by rusting of and old fixing.

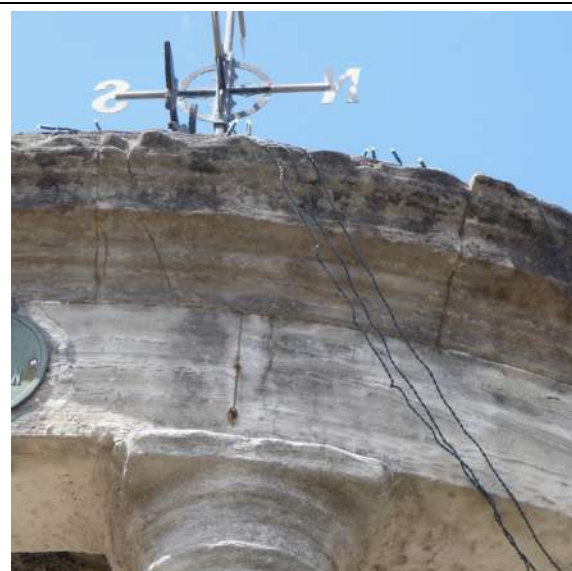
Lintel 1 Old corroding iron fixings in the vertical joint. These appear in a few other places too and all should be removed.

Action	Item	Cost
2	Lintel 8: Remove stub of iron pin from the cornice and make good the cornice profile with mortar repair. Lintel 1: remove old iron fixings from around the bronze plaque and make good holes.	(M)
5	Check vertical joints between all other Lintels and remove old nails. Make good the holes	(S)
D	Gen: Add a lead capping blade all the way around the cornice top to help water drip clear of the eroding stone	(M)
O	Gen: Monitor areas of minor cracking in case of any deterioration. In particular Lintel no5.	(Z)

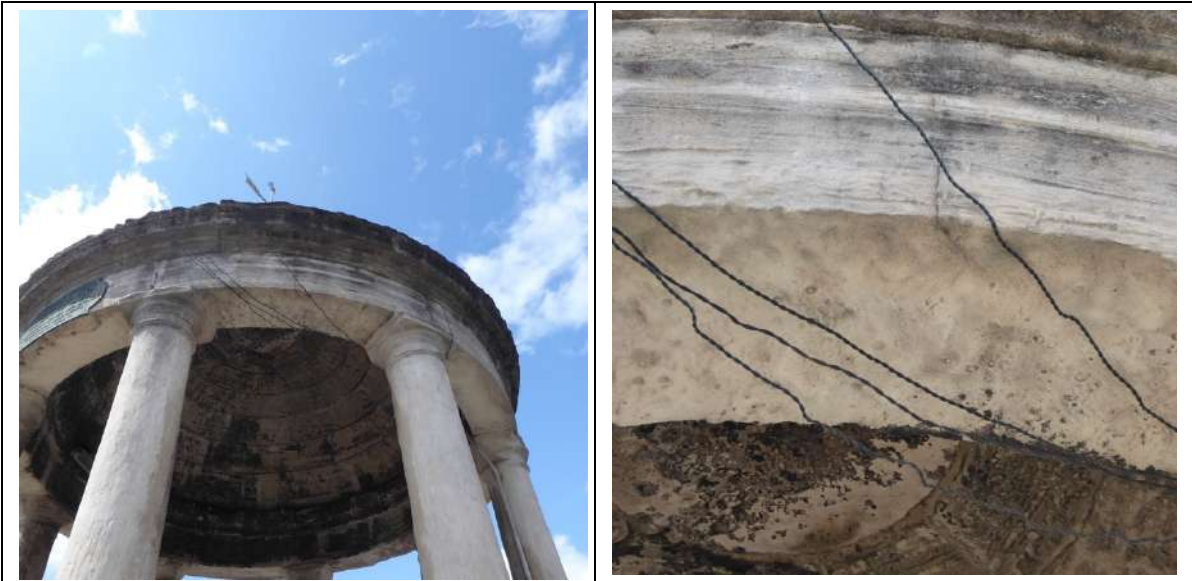
Lintel 2. Possible small crack in the soffit edge. The edges of this are weathered and dirty suggesting it is an old defect. This may be a clay seam defect in the stone rather than an actual crack. This should be monitored.

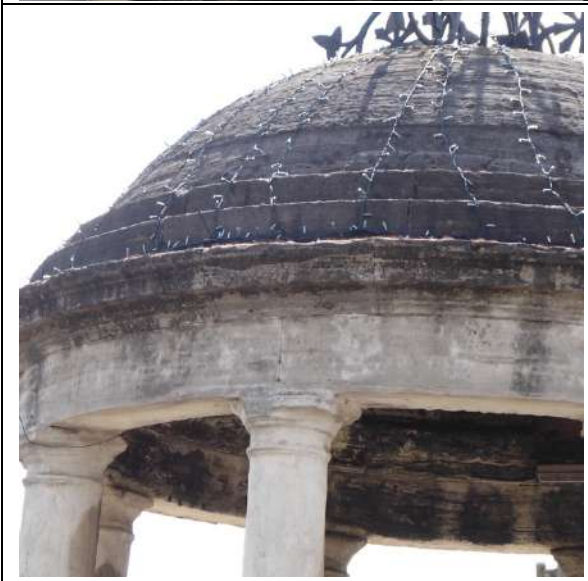
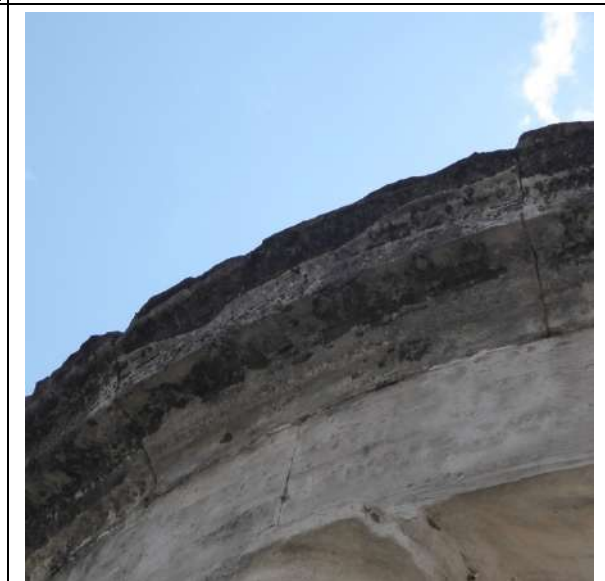
Lintel 4. General views. Iron pins in the vertical lintel joint. Outer edge of the cornice is very notched by erosion on this side.

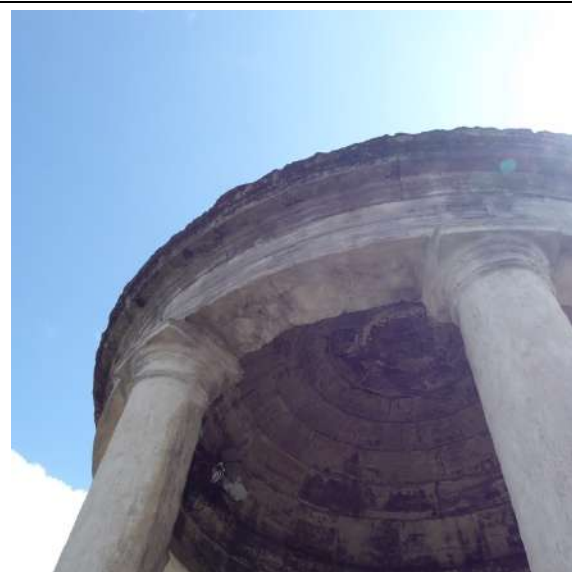
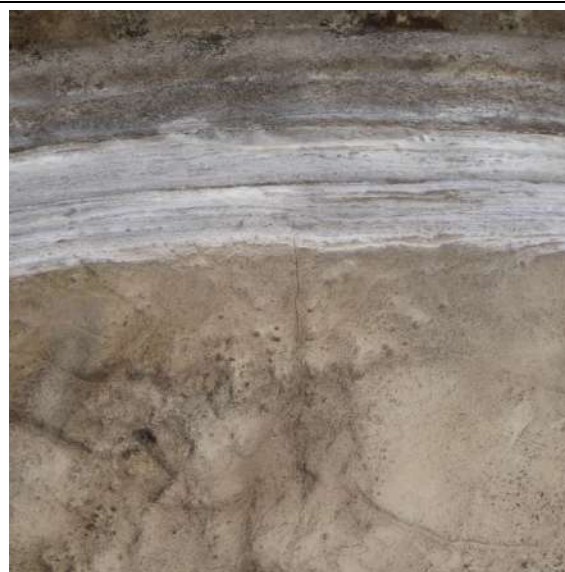
Lintel 5 (West). Soffit of the lintel more eroded and a possible small crack. Possible small crack in the soffit edge. The edges of this are less weathered suggesting it is more recent. This should be monitored.

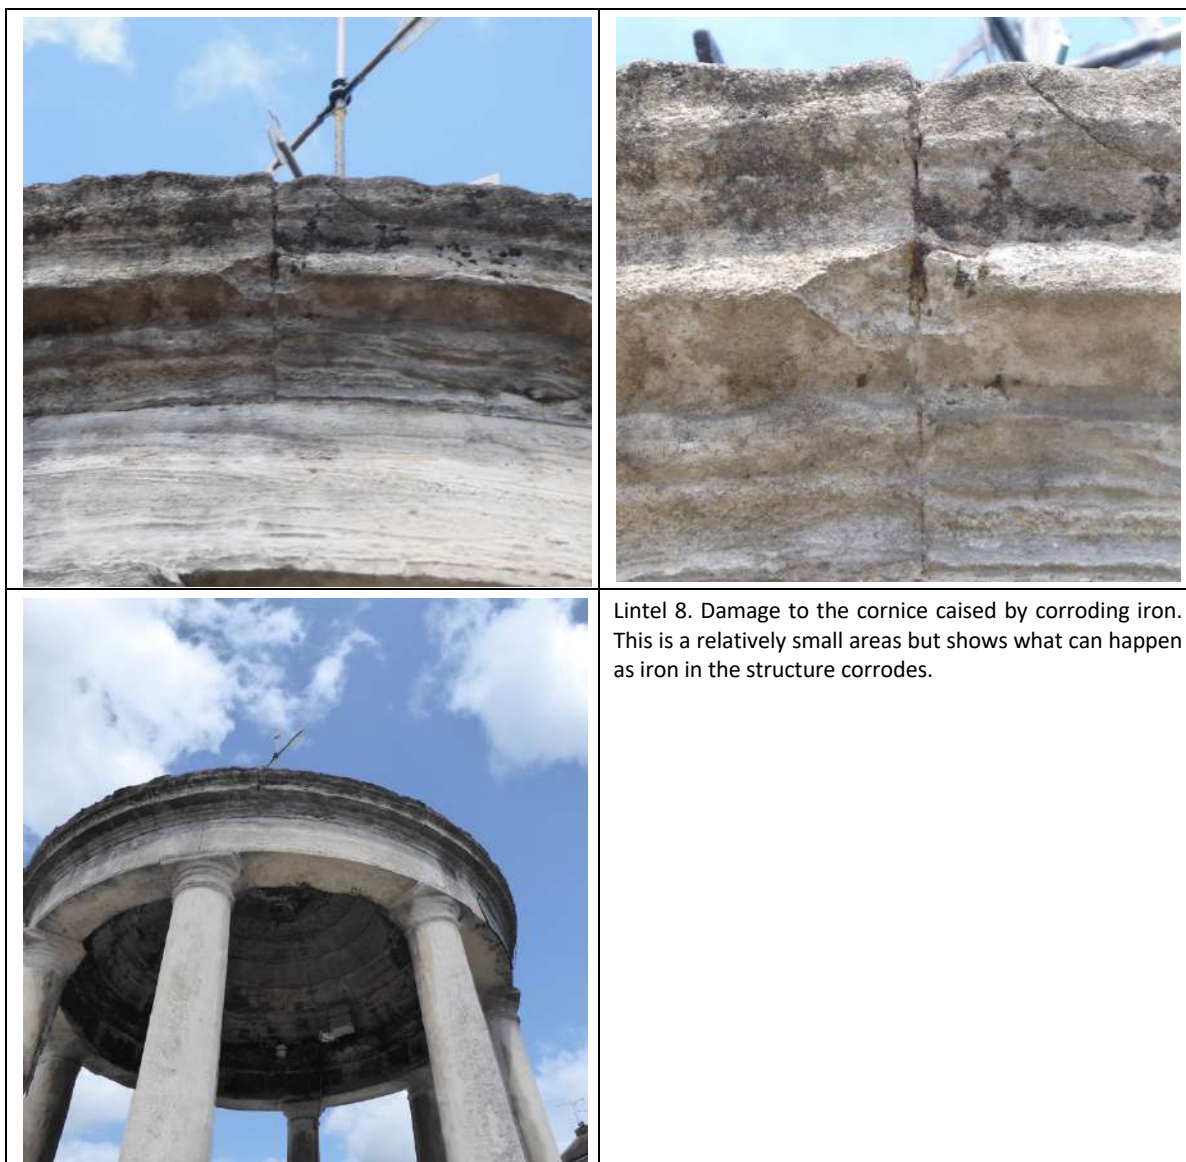
Lintel 8. Damage to the cornice caused by corroding iron. This is a relatively small areas but shows what can happen as iron in the structure corrodes.

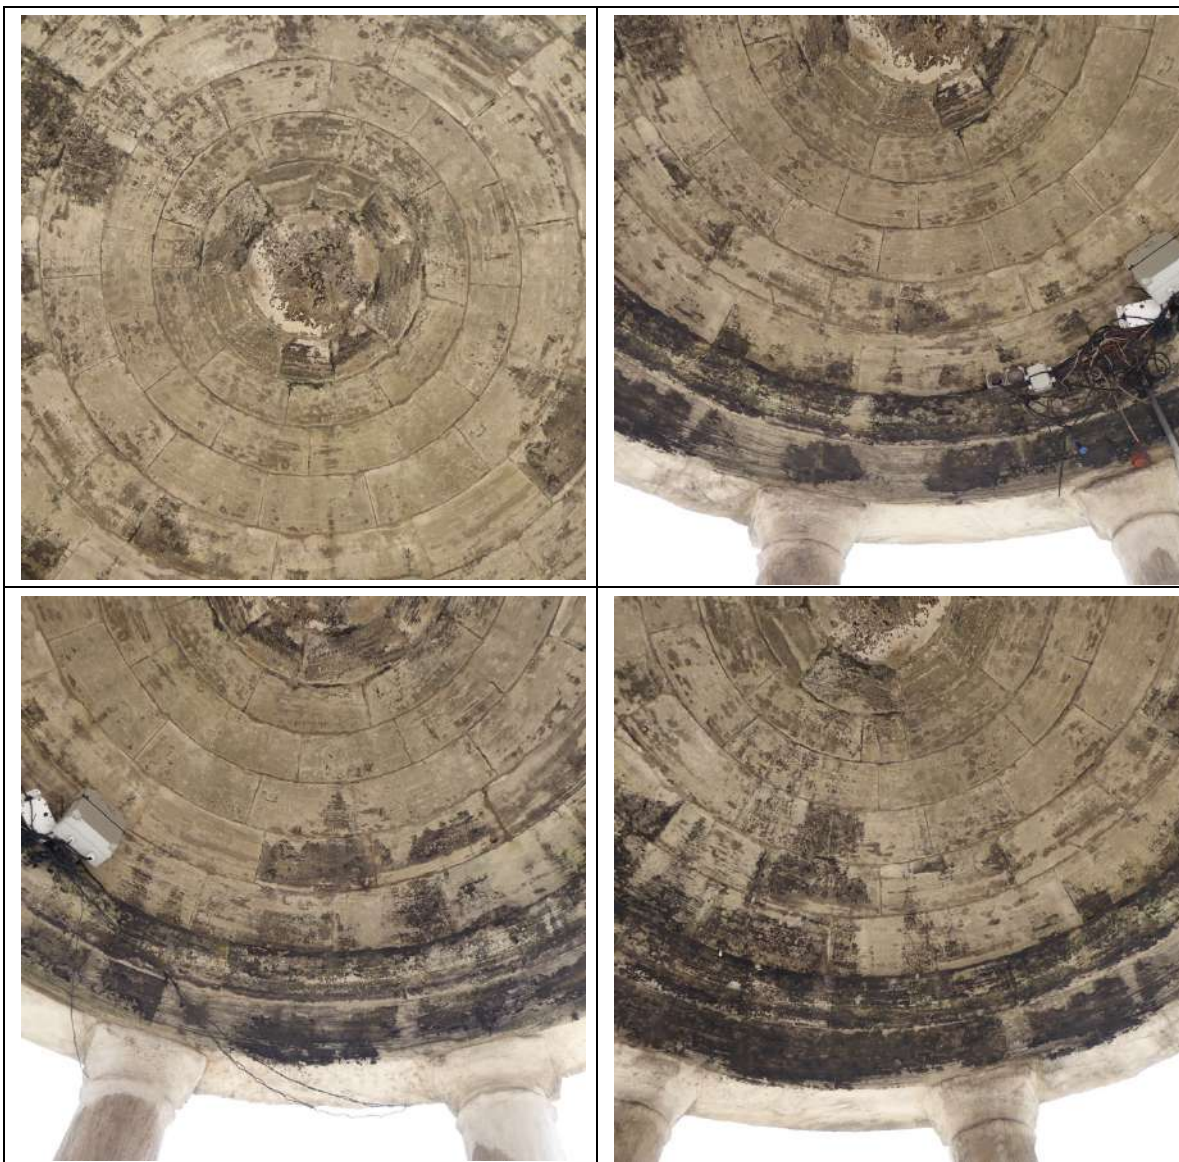
The inside of the stone structure has a build-up of a blackened gypsum crust. This is caused by minerals in the stone dissolving and depositing on the face as they dry – like a dripping well. This can cover defects in the stone and it might be beneficial to have this removed.

Inside of Dome. General views. The cluster of cables and electrical components is on the north side. The black deposit is a gypsum crust that has soot and other contaminants out of the once dirty air. This is similar to the kind of deposit that makes a dripping well or stalactites. Ideally this would be removed but it is not urgent.

Action	Item	Cost
2	Competent electrician to access the electrical installations. Test the system for safety and remove redundant wiring and fixings. Replace the rusty light fitting and clip wiring in a way that does not encourage bird nesting.	(M)
D	Carefully remove the gypsum crust from the inside of the dome vault using a low impact blasting (laser, steam or light abrasive)	(M)

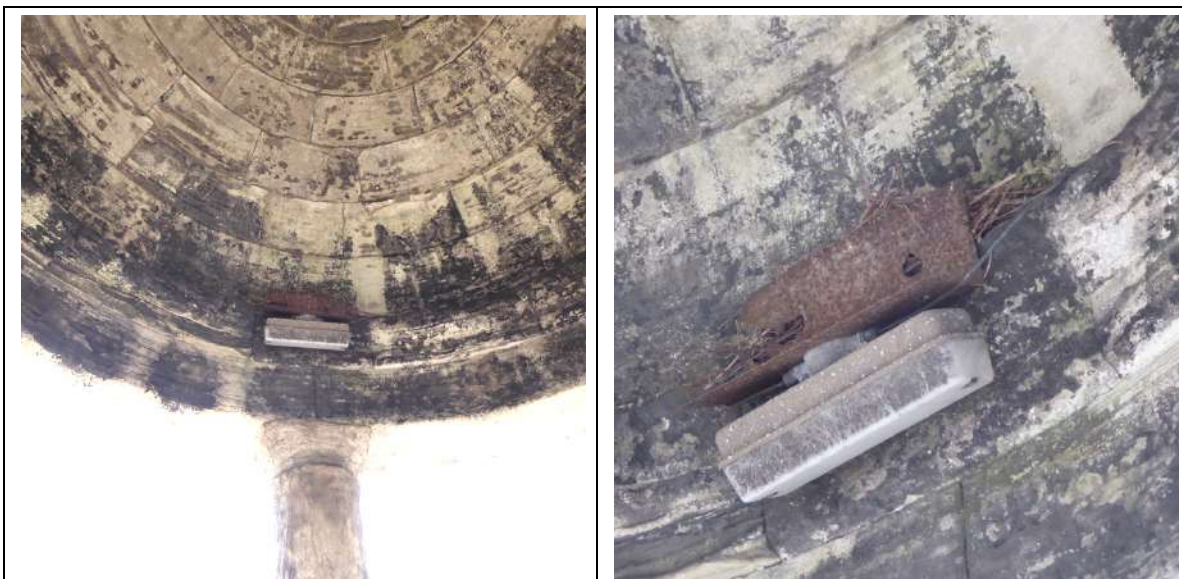
There is an old electric light on the south side, with a rusty iron plate behind. This is now overlaid with nesting material. This all needs to be replaced. There is a loose-hanging wire on the east edge.

Light fitting at the south side is corroded and hanging off its bracket. Creates good nesting opportunity

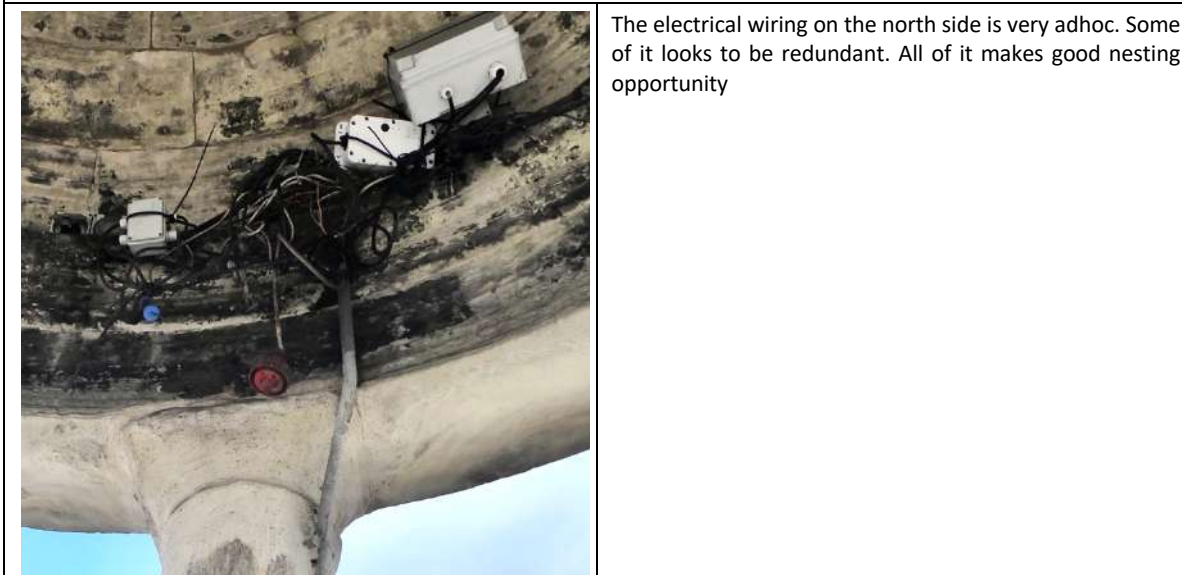
The electrical wiring on the north side is very adhoc. Some of it looks to be redundant. All of it makes good nesting opportunity

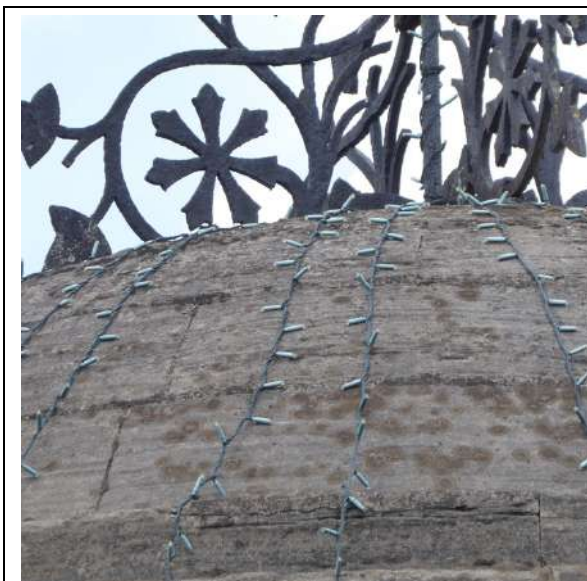
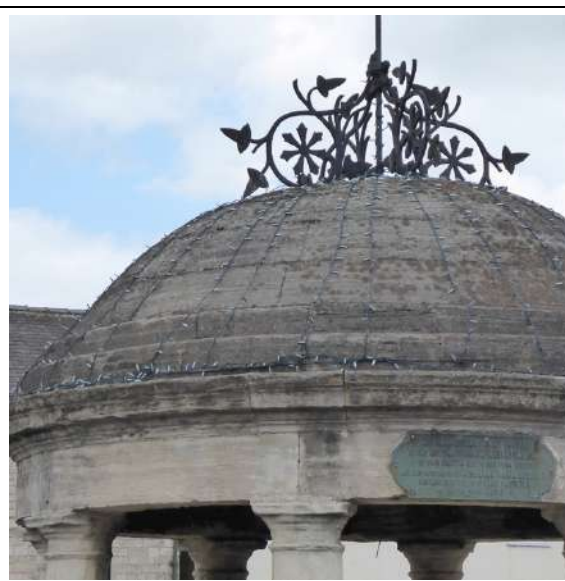
Dome: General views. All generally in good order.

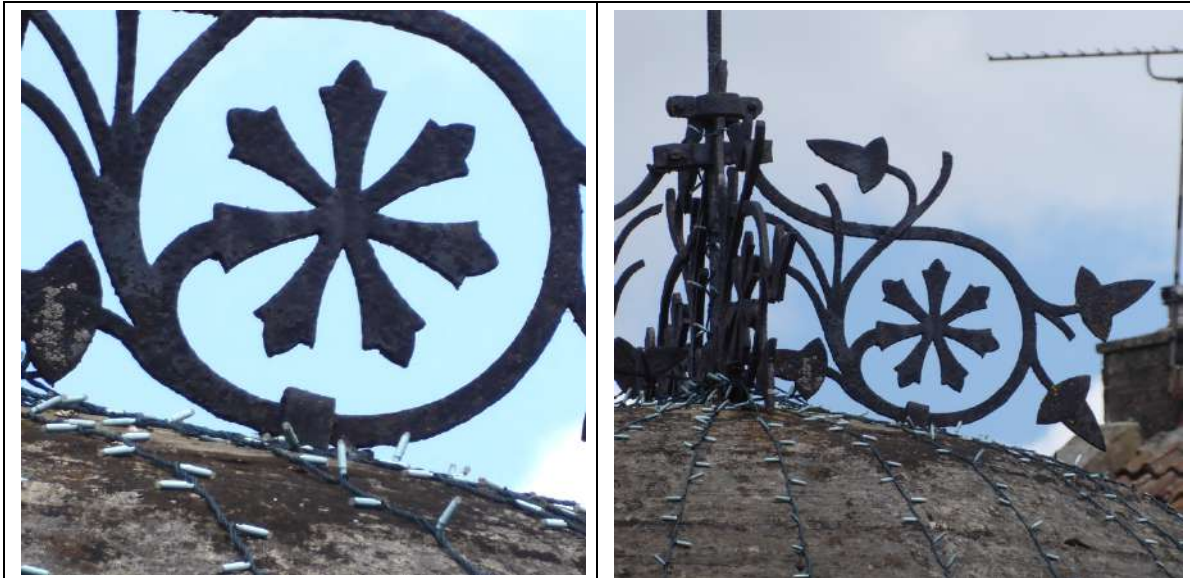
Weathervane: Photos showing loop staples which must be the main fixing we suspect these are set in lead.

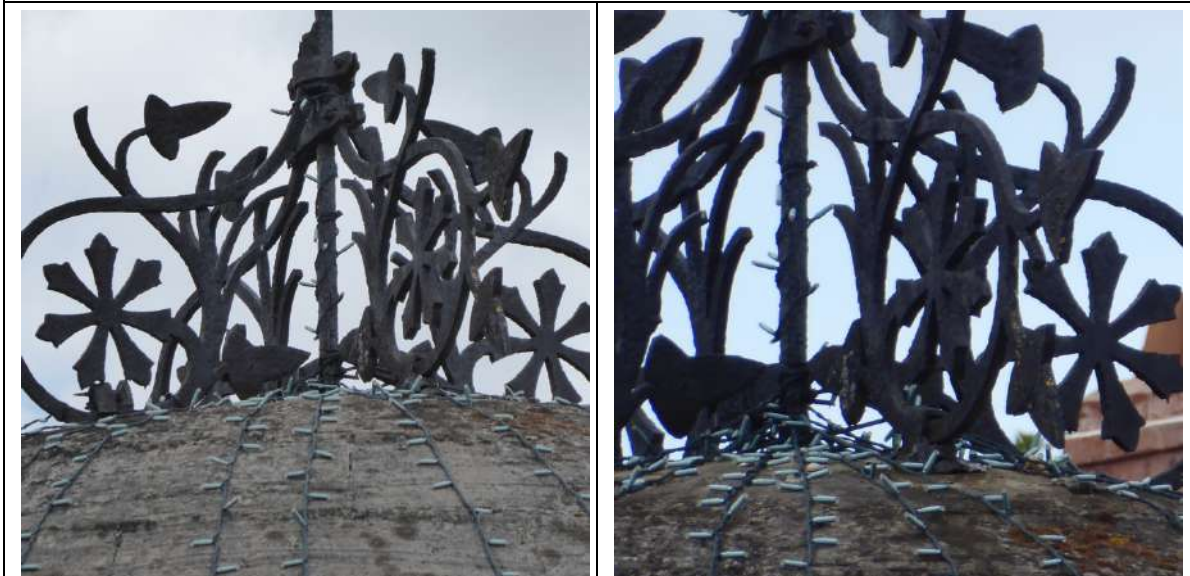
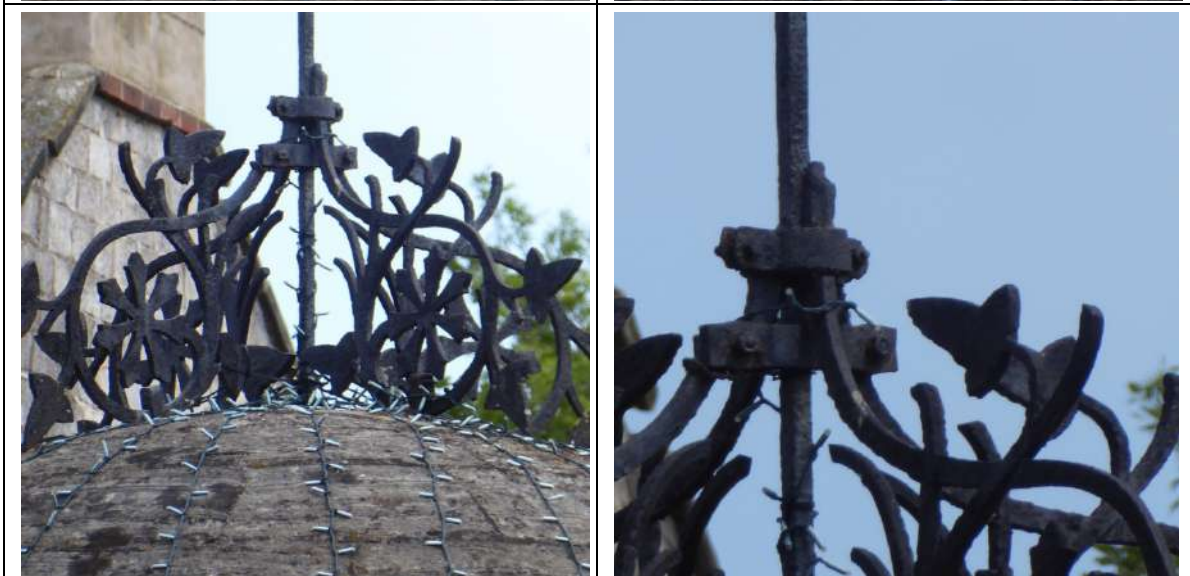
Weathervane: Photos showing the central rod. It is unclear if this is set into the stone or just clamped by the rest of the

ironwork. The flaky condition of the paint is visible in these.

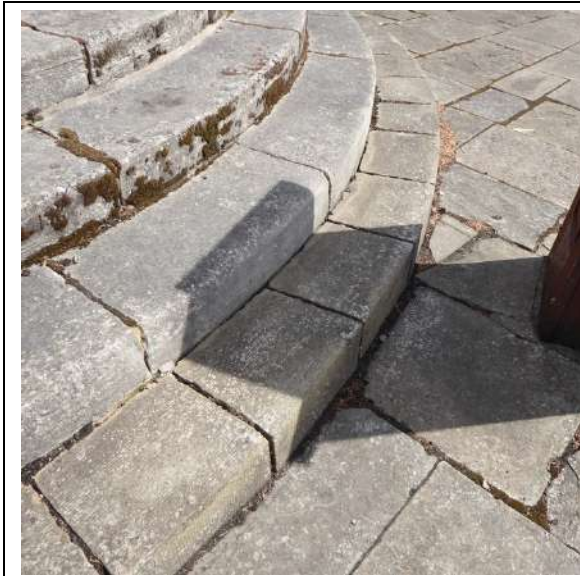
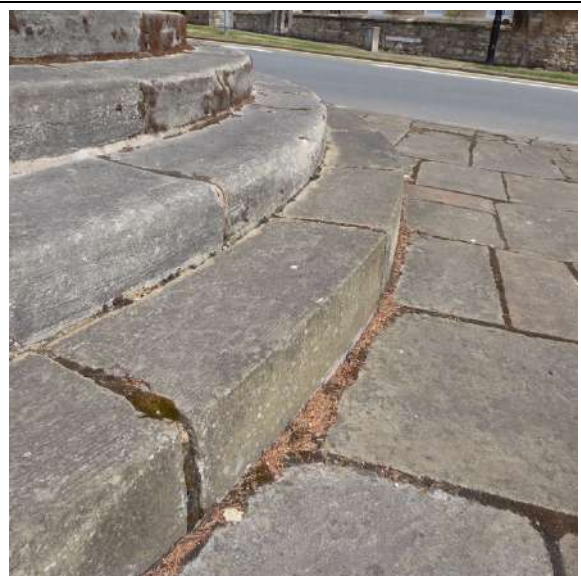
Moss growth and open joints to the lower steps. The bottom step looks to be much newer. This may have been replaced as part of repaving of the whole market square?

Action	Item	Cost
2	Replace the capping timber to the old water pump in a resilient hardwood and repaint the whole feature	(S)
5	Cut out existing mortar and moss from the whole stepped plinth and repoint in a good quality gritty lime mortar	(M)

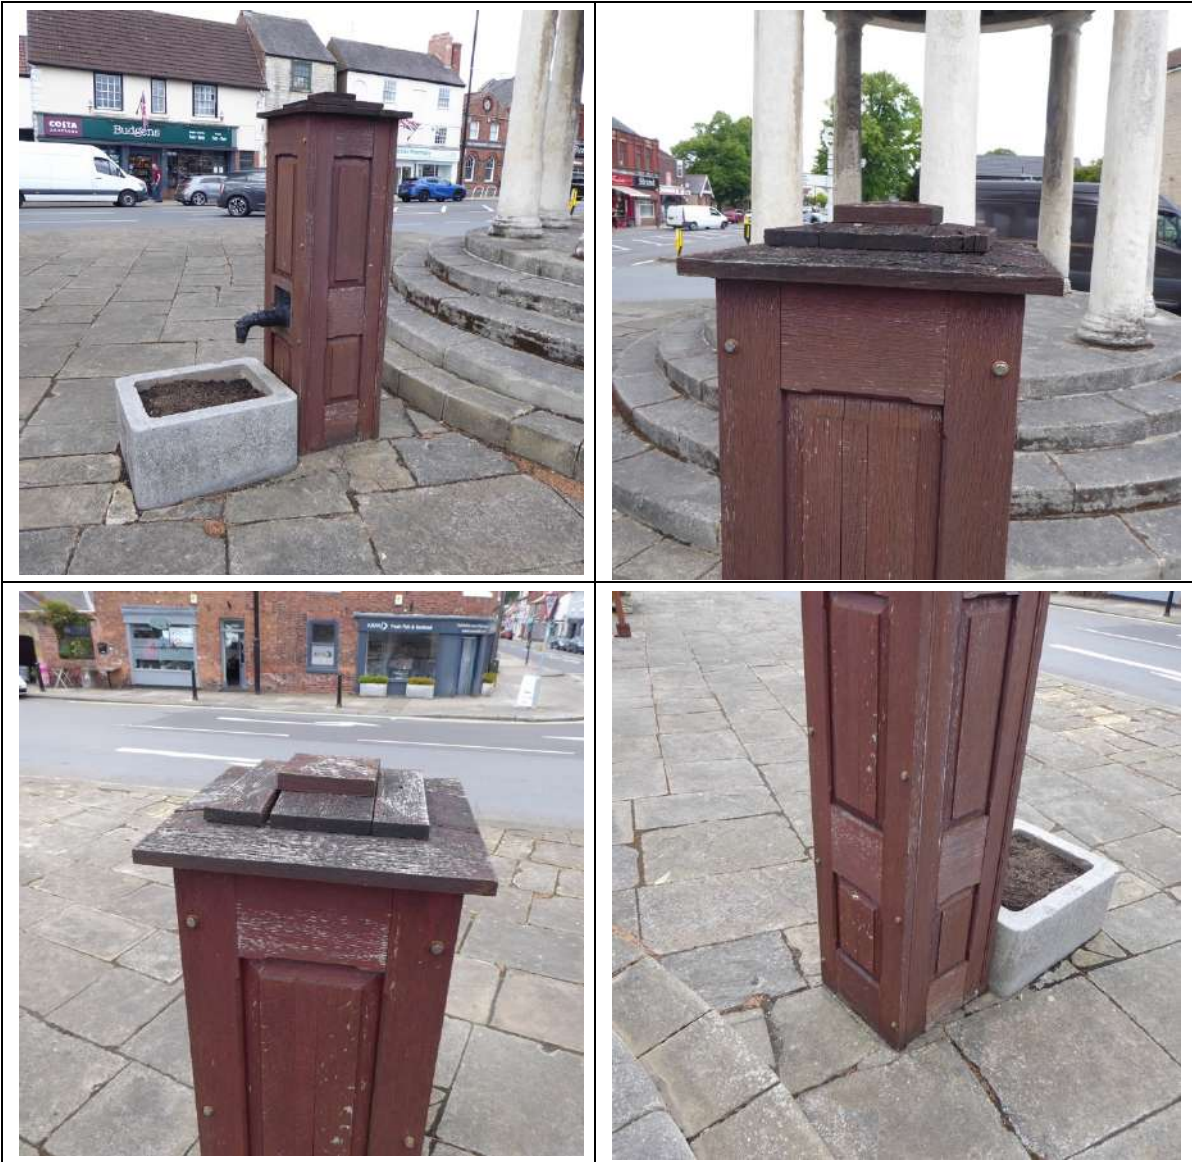
The old water pump feature alongside the Buttercross has quite nicely made side cladding, but the top capping is poorly constructed and now heavily weathered. The timbers could do to be replaced. The whole paintwork finish could do to be brushed, rubbed down and renewed.
