TICKHILL BUTTER CROSS

GRADE II LISTED

CONDITION INSPECTION REPORT

For the Tickhill Town Council
Doncaster MBC, Listed Building Legacy ID: 334354 NGR: SK 59278 93281
Date of primary Inspection 6th June 2025
Weather: Dry and hot for some time
Inspection status: First by this Architect

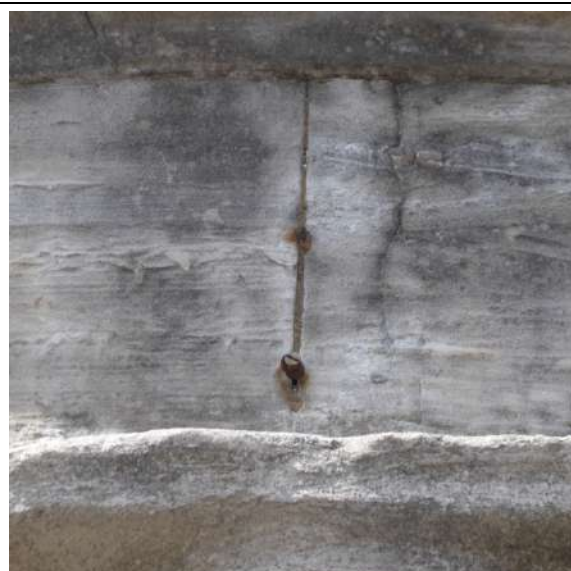
Lintel 1 Old corroding iron fixings in the vertical joint. These appear in a few other places too and all should be removed.

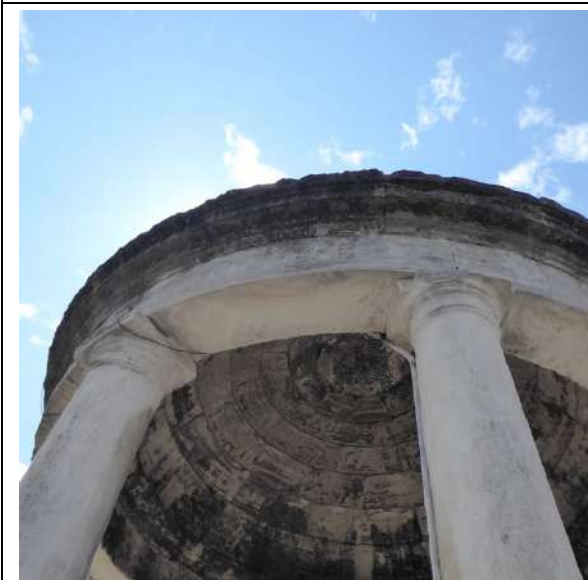
Lintel 2. Possible small crack in the soffit edge. The edges of this are weathered and dirty suggesting it is an old defect. This may be a clay seam defect in the stone rather than an actual crack. This should be monitored.

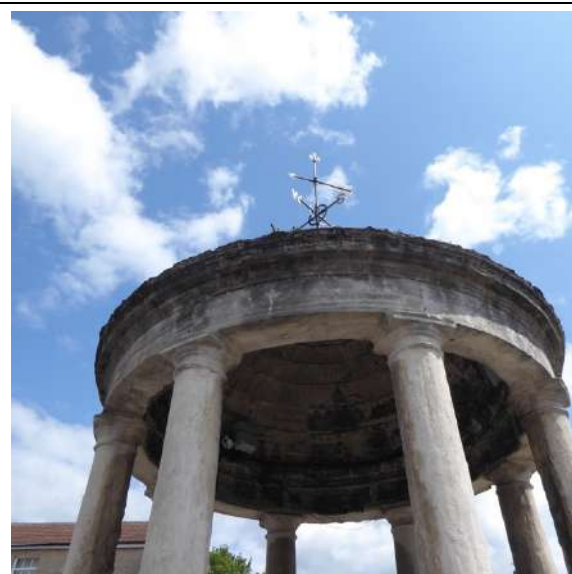
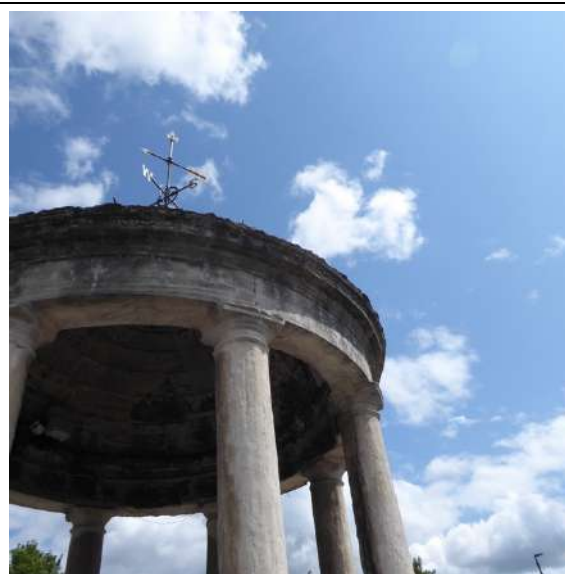
Lintel 5 (West). Soffit of the lintel more eroded and a possible small crack. Possible small crack in the soffit edge. The edges of this are less weathered suggesting it is more recent. This should be monitored.

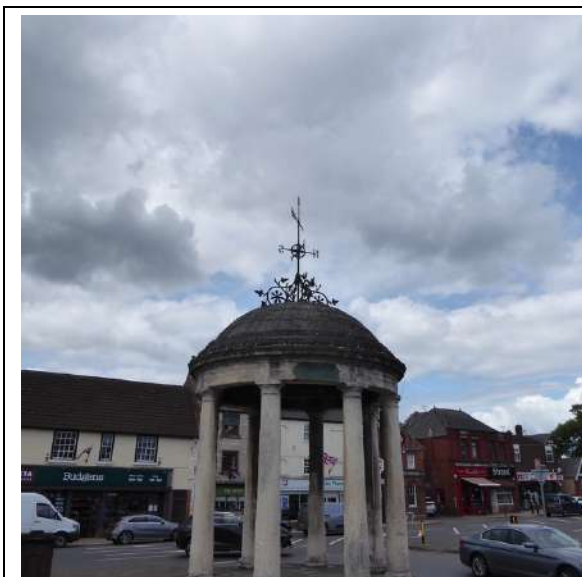
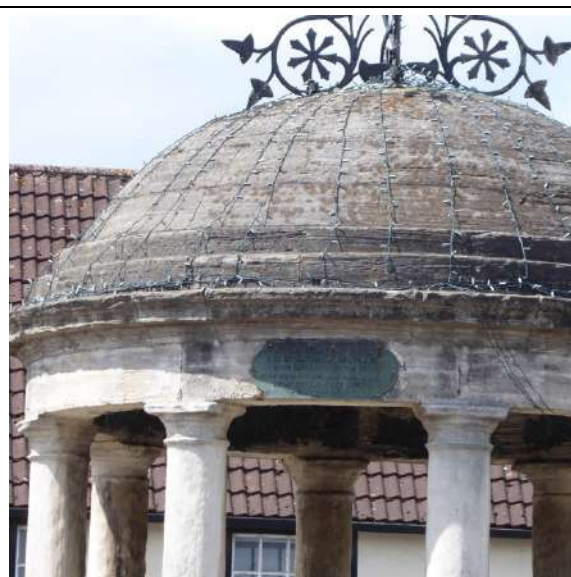
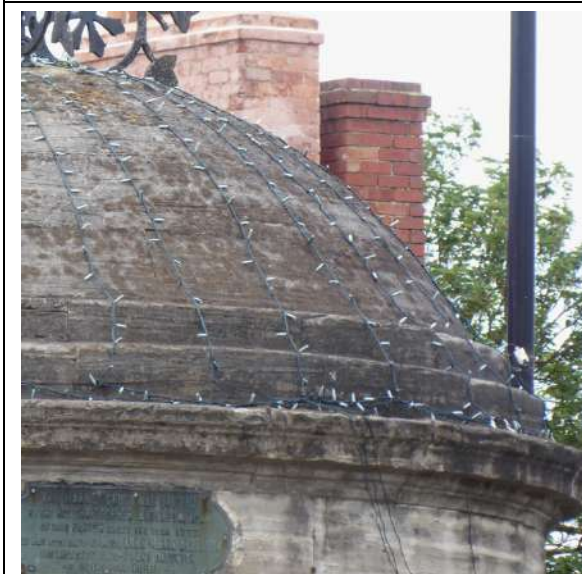
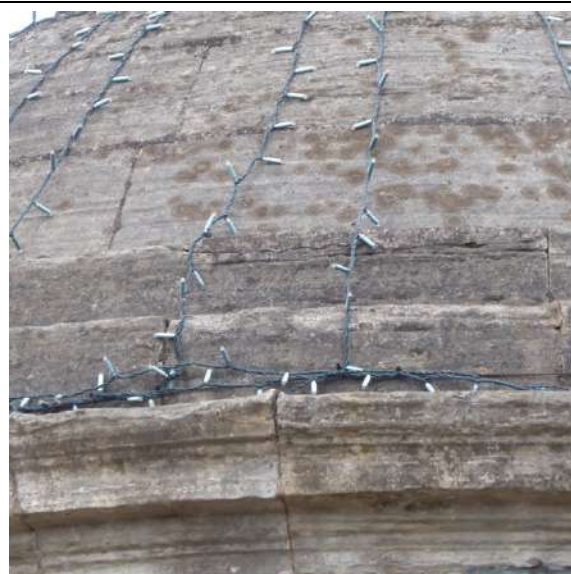
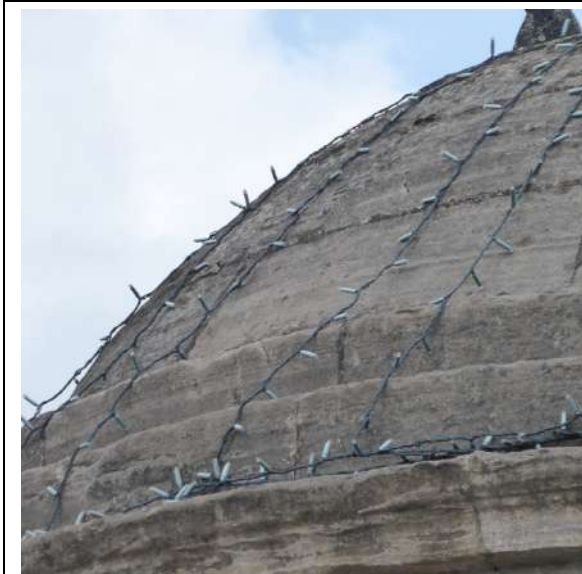
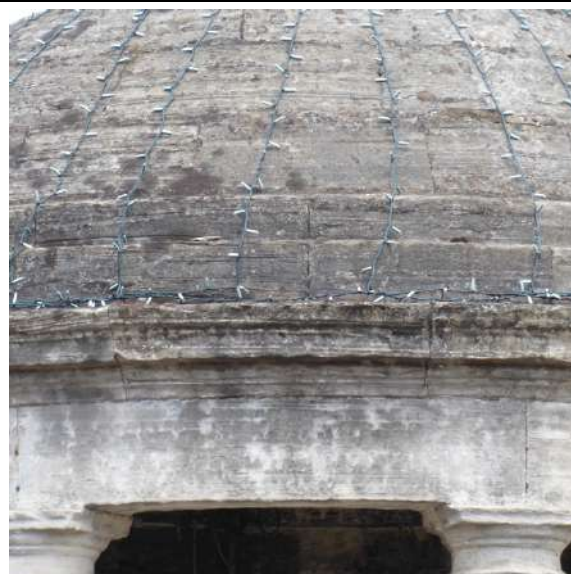
The actual paint finish on the metalwork itself does not seem too bad. It looks like it might have been repainted at some point in the recent past as part of a maintenance campaign by the Council. This will probably be needed again in around 5 years.

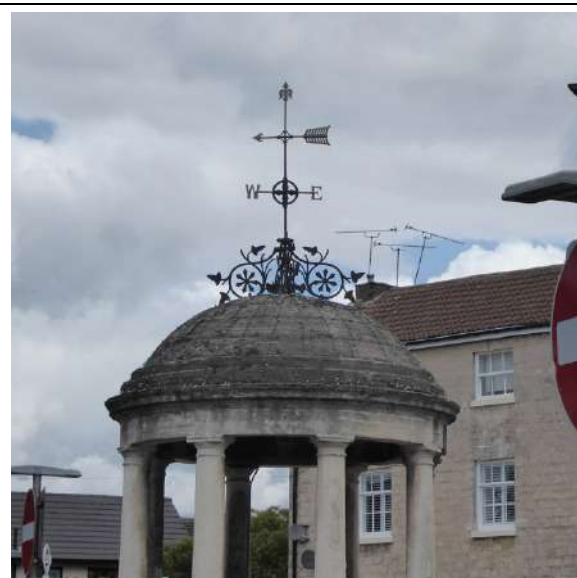
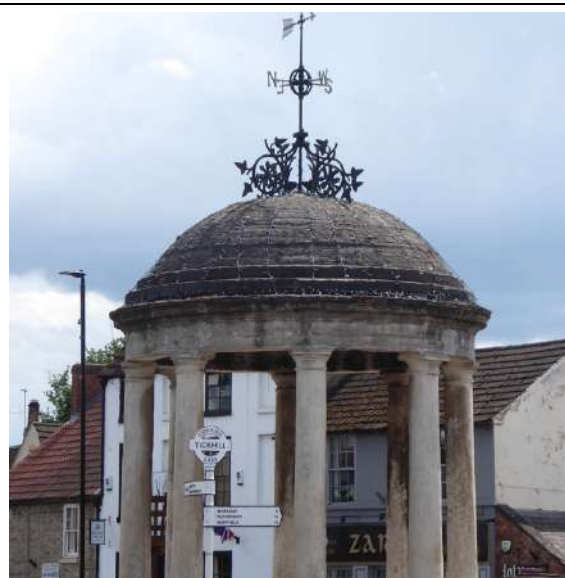
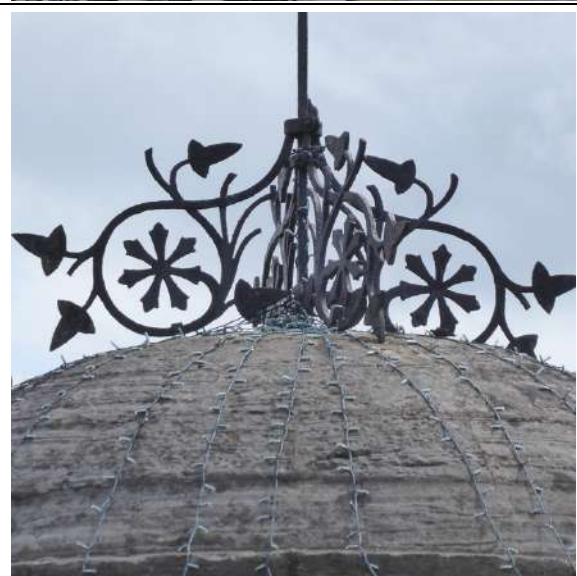
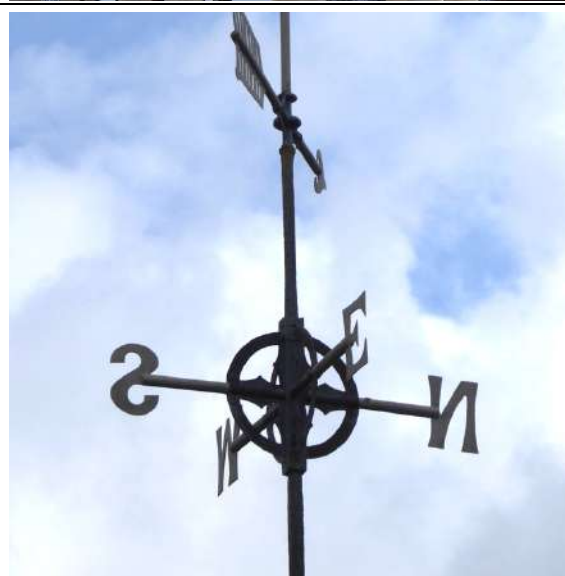
Dome: General views. All generally in good order.

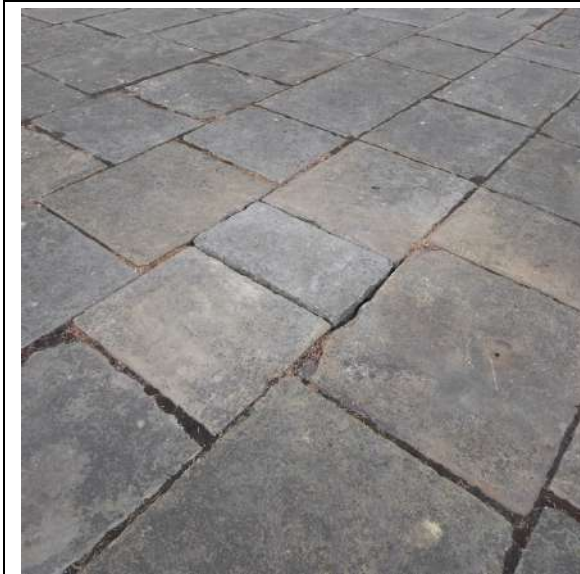
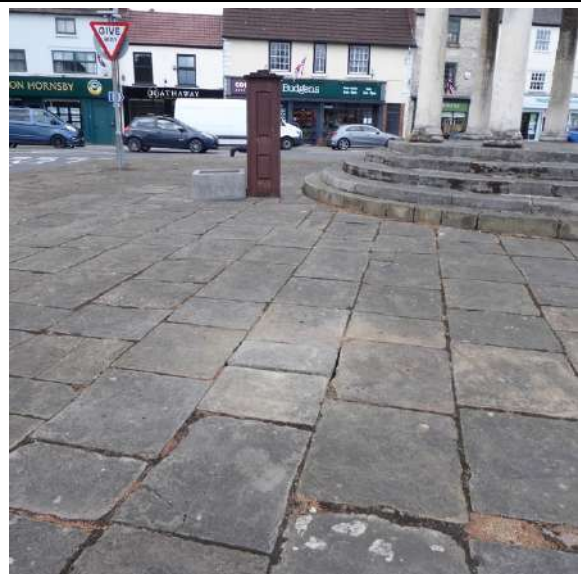
Moss growth and open joints to the lower steps. The bottom step looks to be much newer. This may have been replaced as part of repaving of the whole market square?
